ORIGINAL ARTICLE

Periorbital venous stasis may be involved with filler induced malar edema—A duplex ultrasound-imaging-based case series

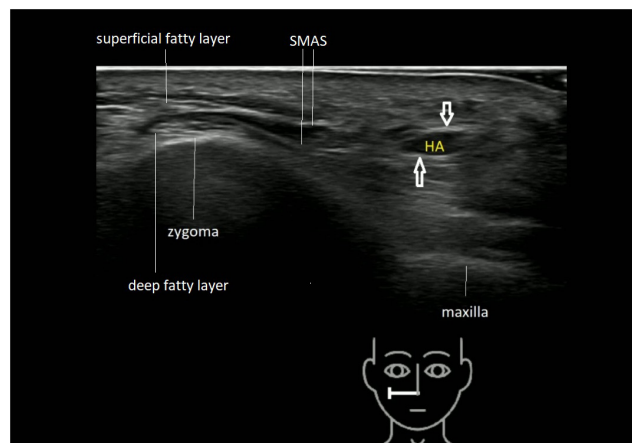
FIGURE 1 Hyaluronic acid filler deposit in the SMAS. The SMAS layer is expanded by filler.

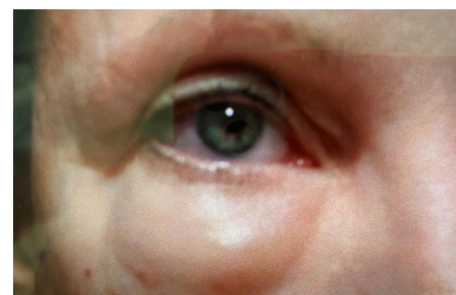
FIGURE 3 Severe edema.

Seventeen patients and in total 26 periorbital areas underwent ultrasound guided injections into the filler deposits leading to decrease or clearance of filler deposits. Twenty-three filler deposits injected with hyaluronidase were located in the SMAS in the region of the medial SOOF. In three cases, the filler deposits were visible on the periosteum of the orbital rim and dissolved with hyaluronidase. Ranges of 50–125 units of hyaluronidase (Hyason®) were used per treatment with an average of 100 units. Minutes after treatment, clinical improvement of malar edema was observed (Figure 4). Two patients returned for a second treatment session, two other patients with severe edema (Figure 3) needed three treatment sessions. No other medication was given.

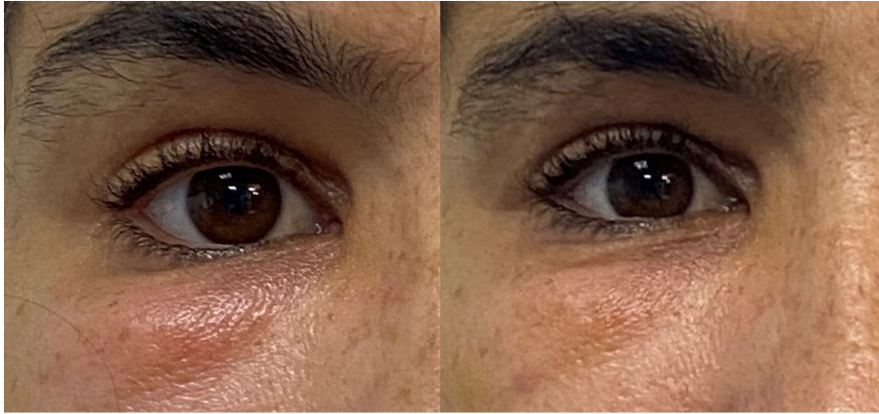
FIGURE 4 Left: before hyaluronidase treatment. Right: 10 min after hyaluronidase treatment. Direct clinical improvement is noted.
